# CONDITION SURVEY, WESTOVER AIR FORCE BASE, MASSACHUSETTS

R. D. Jackson

June 1973

Conducted by U. S. Army Engineer Waterways Experiment Station  
Soils and Pavements Laboratory  
Vicksburg, Mississippi

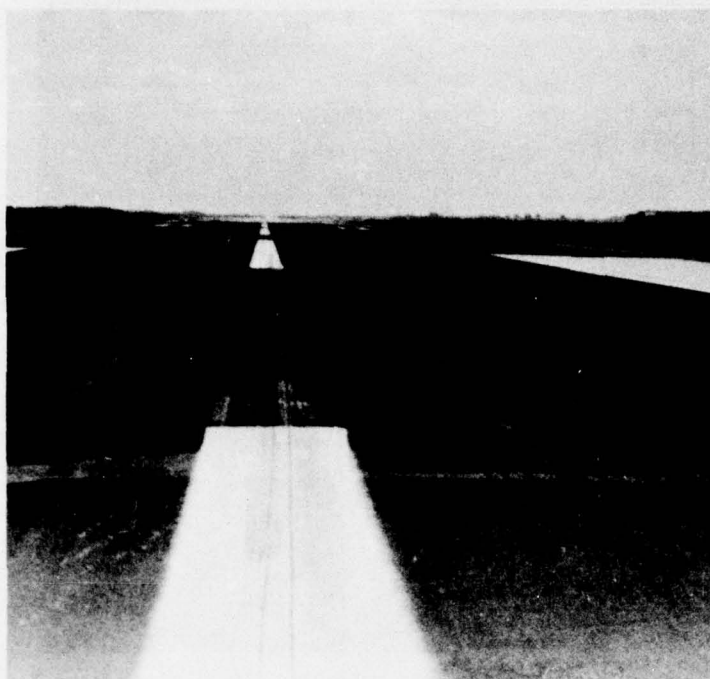
NE end (15-in. PCC pavement), features R5A and R4B, was also in excellent condition, with only five major defects noted. The interior AC portion was in very good condition (photos 1 and 2); a slurry seal had been applied during 1972 before this condition survey was performed. Photo 3 shows a closeup view of this slurry seal on the NE-SW runway. The NW-SE (15-33) runway pavement, which is AC over PCC, appeared to be in only fair condition, with considerable reflection and random cracking (photos 4 and 5).

Photo 1. General view of NE-SW (05-23) runway  
looking southwest from NE end of AC pavement

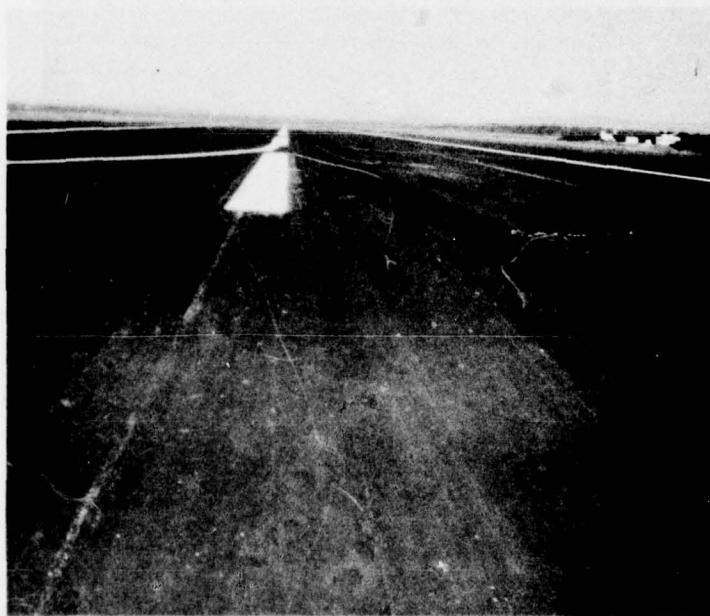
Photo 2. General view of NE-SW (05-23) runway  
looking northeast from taxiway N

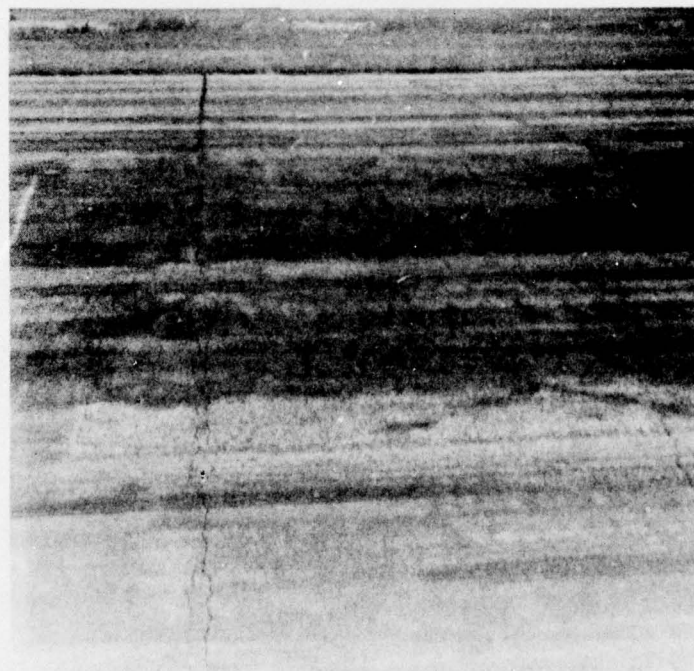
Photo 4. General view of NW-SE (15-33) runway  
northwest of taxiway G

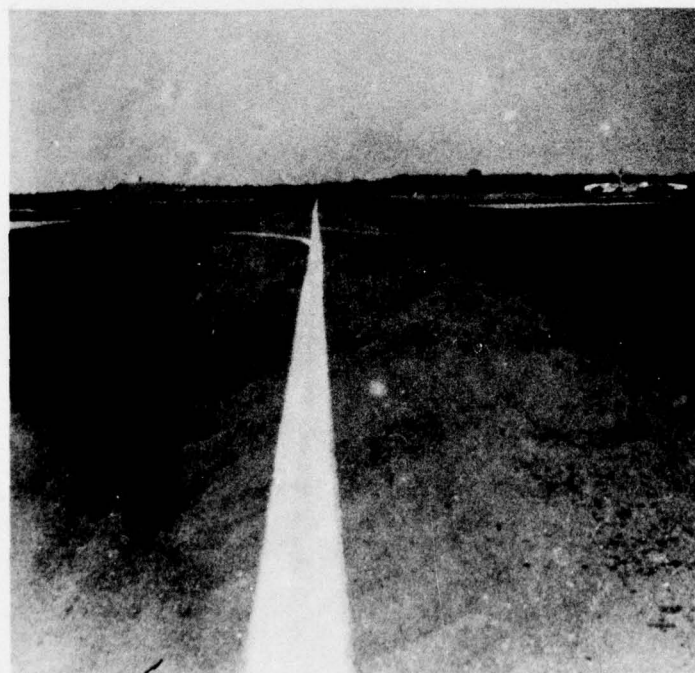
Photo 6. General view of taxiway S looking  
southwest from stub 9

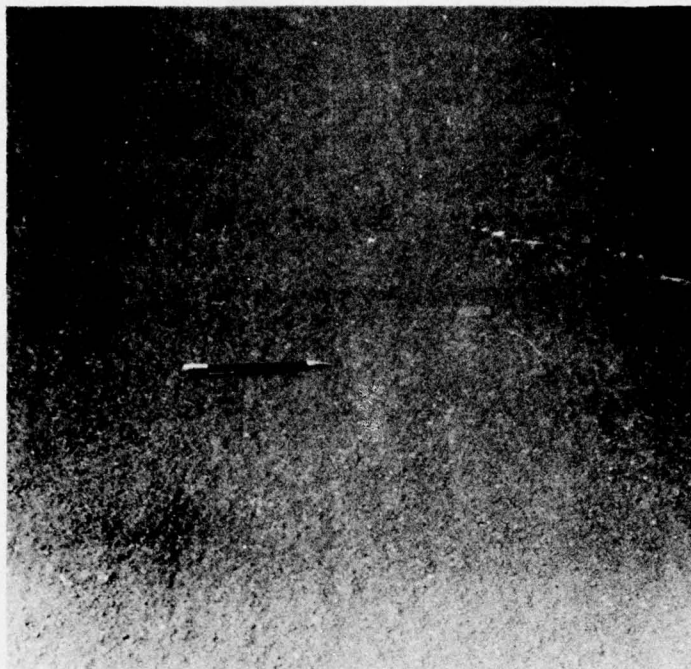
Photo 7. Closeup view of slurry seal on shoulder of taxiway S at parking stub 9

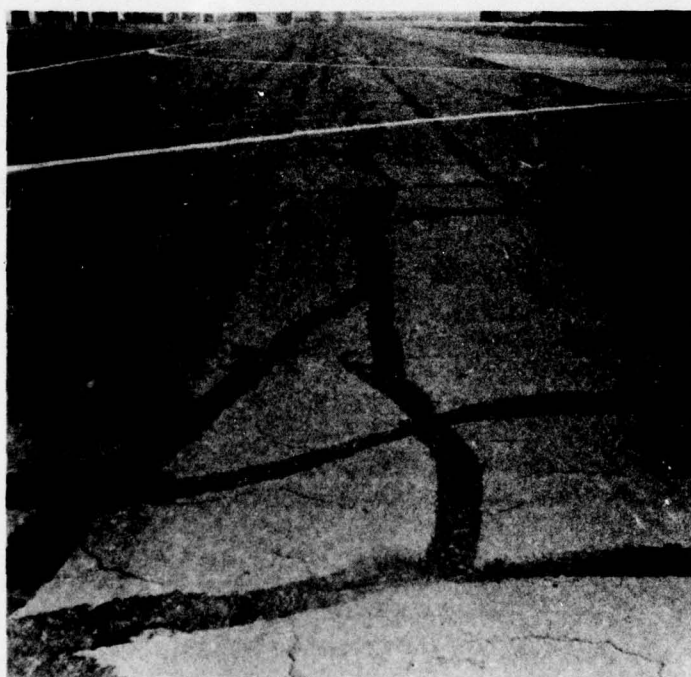
Photo 8. View of shoulder of taxiway S without slurry seal

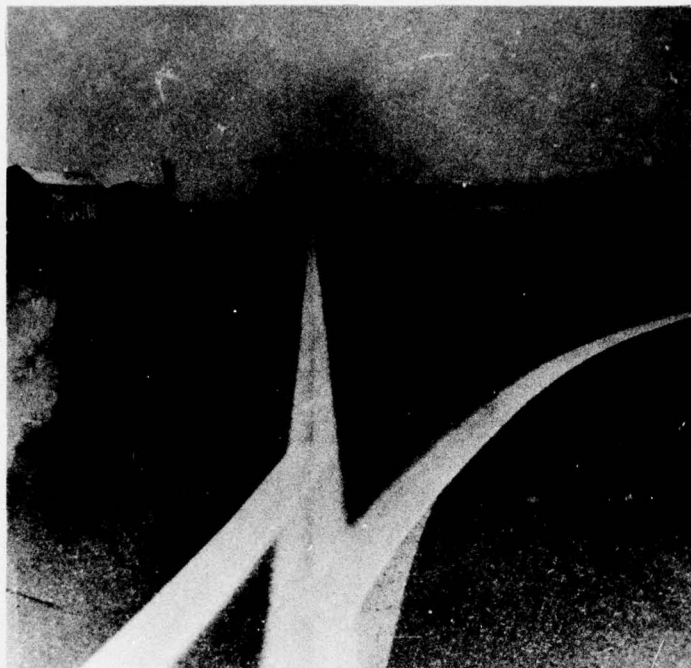
Photo 9. General view of taxiway G along SAC operational parking apron

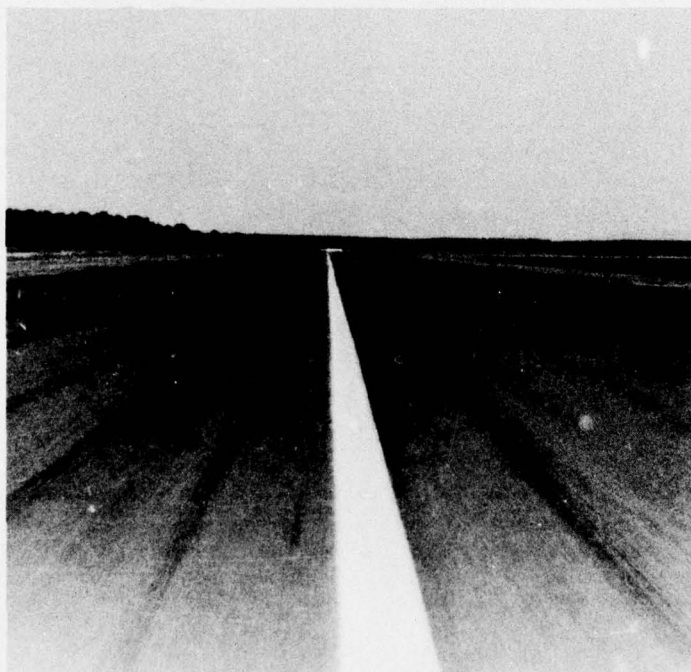
Photo 10. Typical view of NE end taxiway G opposite calibration hardstand
